OPERATIONS & ADMINISTRATION COMMITTEE MEETING

**MONTECITO WATER DISTRICT
583 SAN YSIDRO ROAD**

**Tuesday November 13, 2018
9:30 A.M.**

INSPECTION OF DAM AND RESERVOIR IN CERTIFIED STATUS

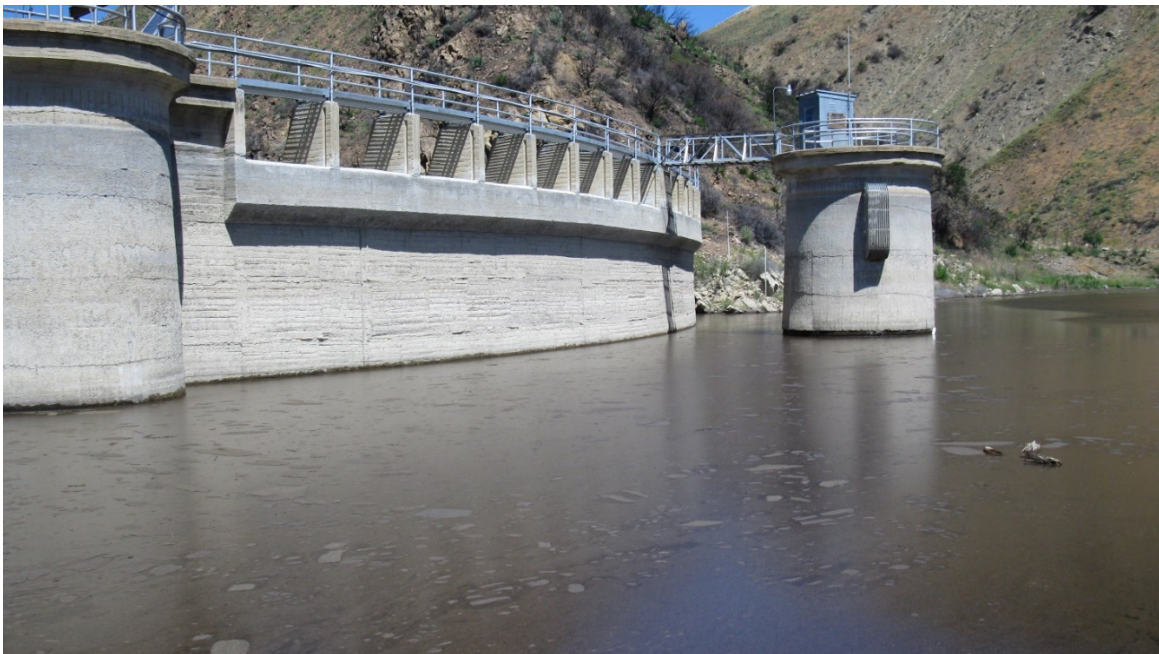
Arch Section: The arch section is the tallest and is identified as the main dam, which also contain the overpour spillway, outlet towers, and emergency outlet valves. The concrete surfaces on both the upstream and downstream faces were in relatively good condition. The abutments appeared tight, with no noticeable seepage. A small tree growing against a concrete wall adjacent the twin 36-inch outlets must be removed. A small seep on the downstream face was observed emanating from a lift joint on the left side of the spillway, 11 lifts down from the crest. The staining indicates this is longstanding. The pool of water collected in the plunge pool at the toe is due to seepage from the lower lift joints. No other detrimental conditions were noted.

Arch Section – Upstream Face

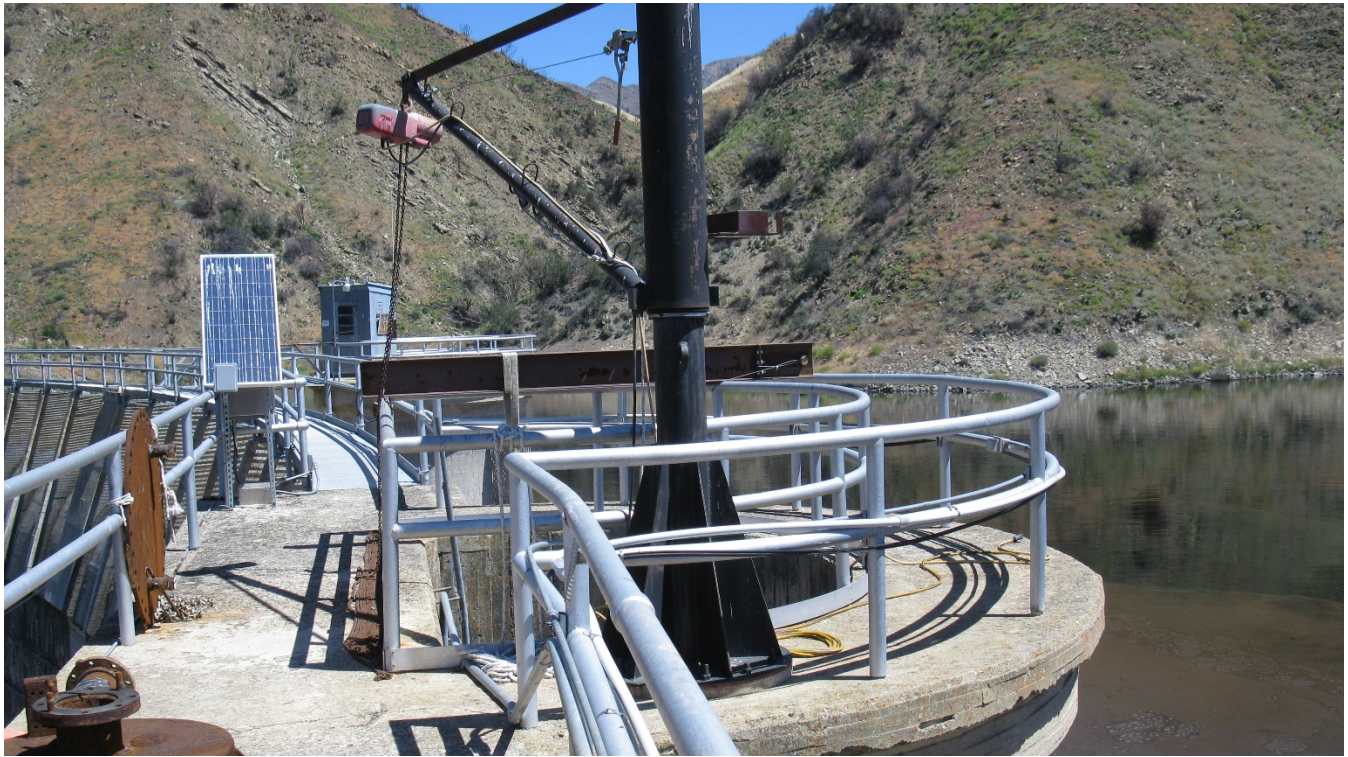
Arch Section – Crest and Outlet Towers

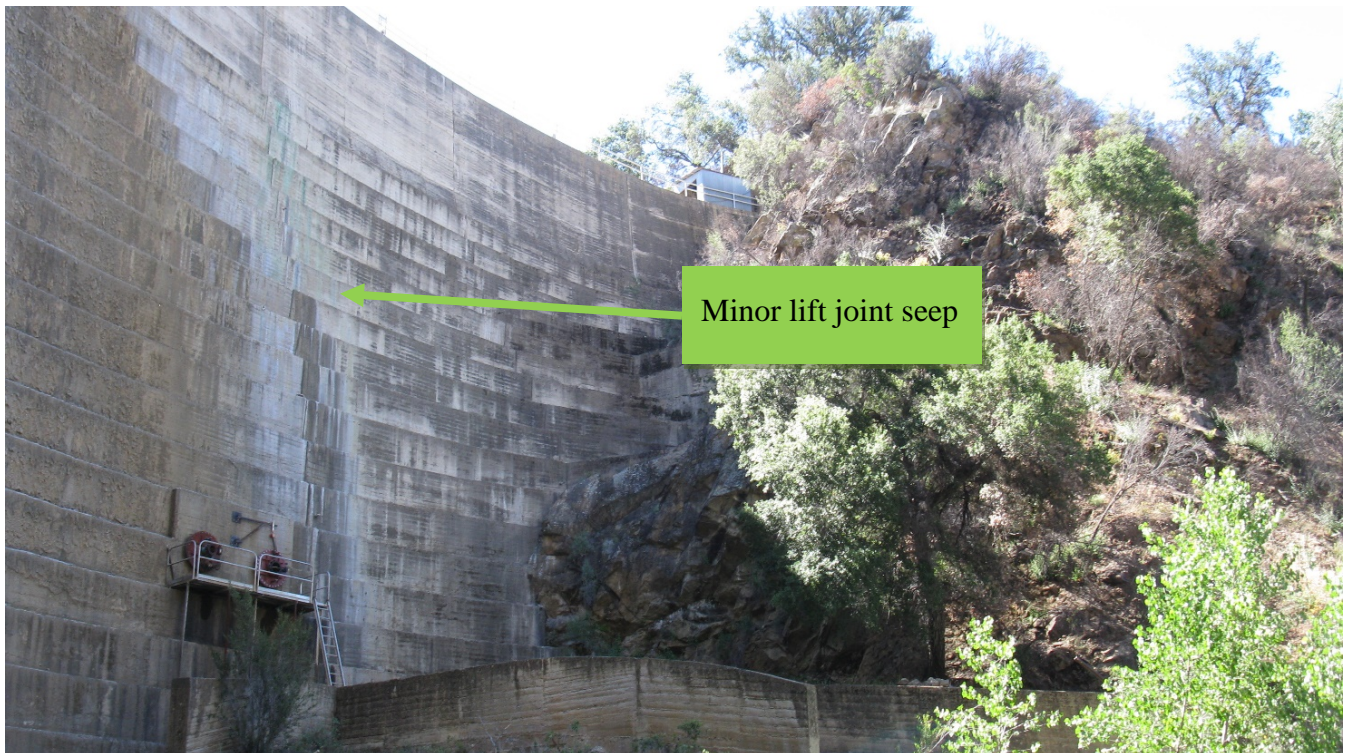
Arch Section – Downstream Face

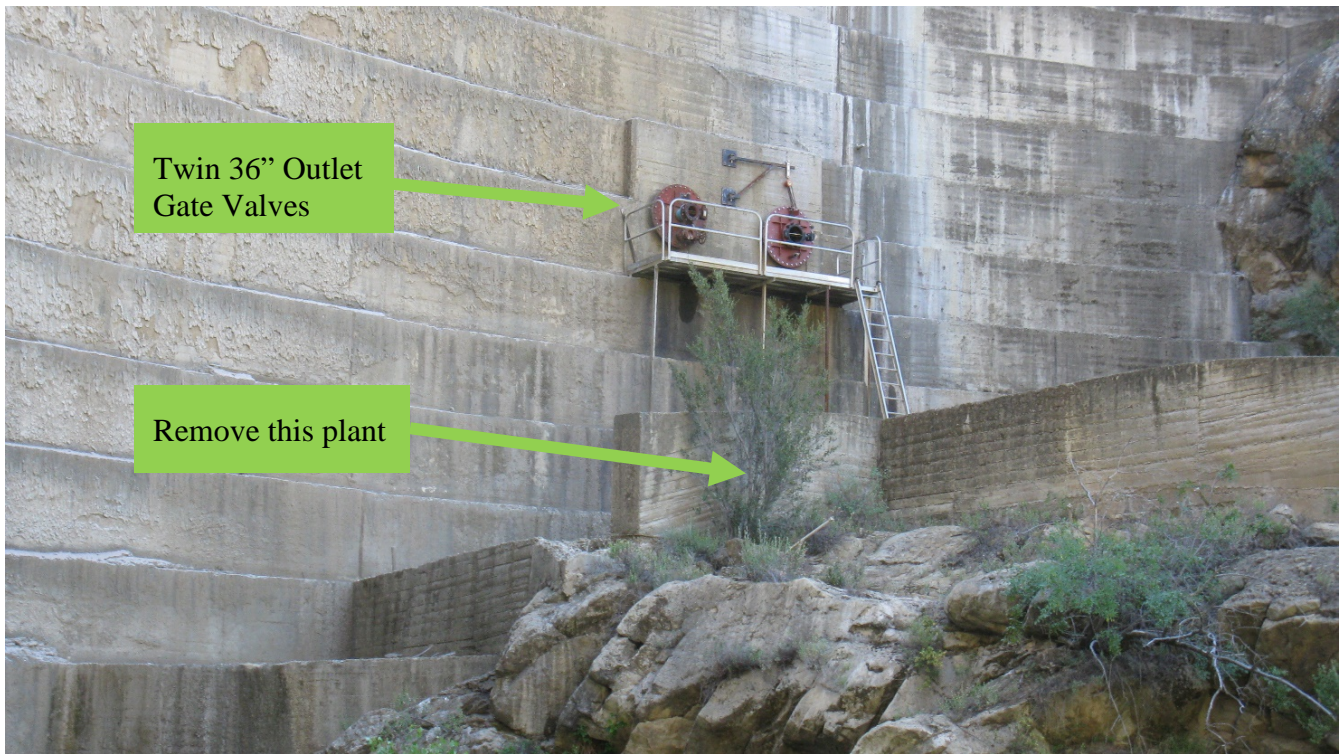
Arch Section – remove the small tree

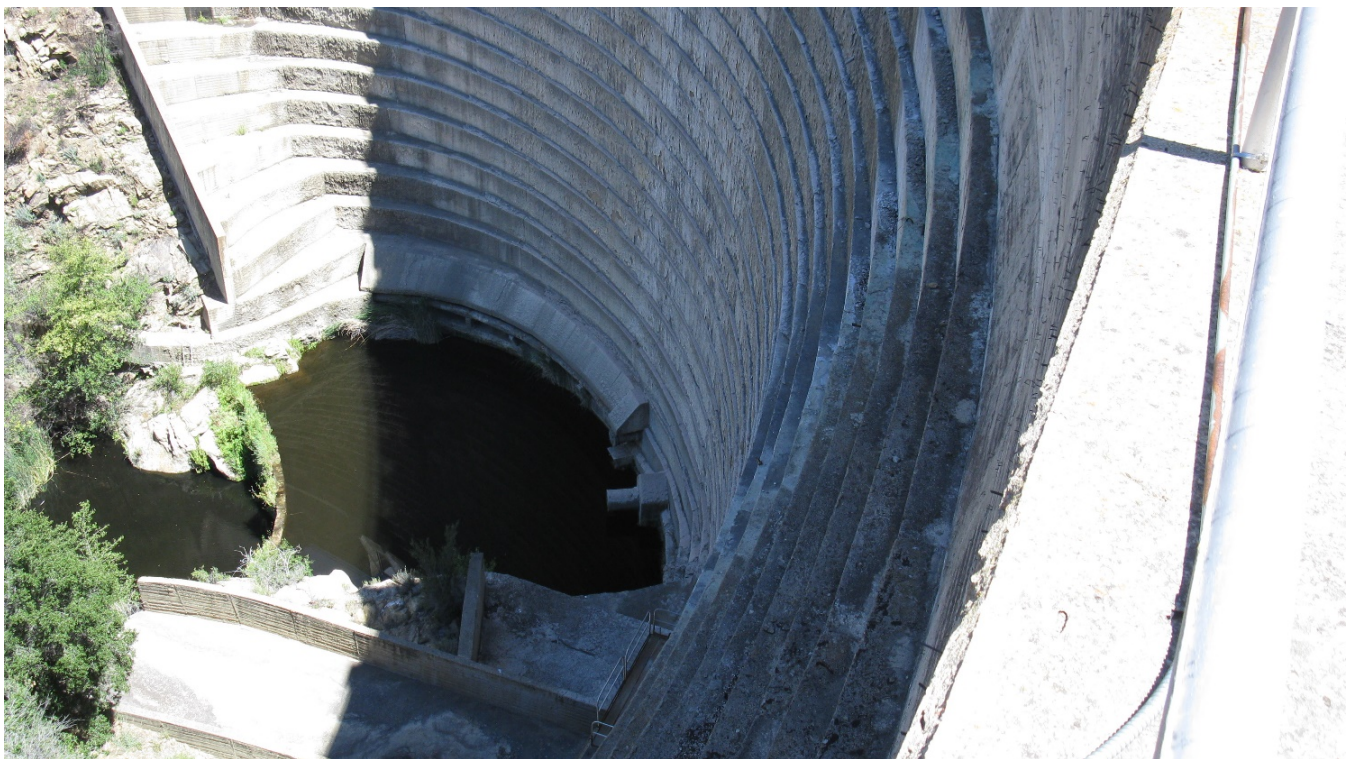
<u>Spillway</u>	The overpour spillway is located on the main dam, and appeared in satisfactory condition. The concrete weir and stepped downstream face were intact, and the catwalk revealed no signs of distress. The joints were relatively tight with a few minor seeps manifested by grasses growing there. Vegetation growing out of all concrete should be removed.
<u>Outlet</u>	The outlets include two 36-inch upstream valves and an 18-inch downstream blowoff valve. The 18-inch blowoff valve was fully cycled satisfactorily. The two 36-inch gate valves were not cycled due to concerns they may not close. There are plans underway to install redundant valves to permit cycling of these valves without risk of water loss.
<u>Seepage</u>	There were a few seeps through the lift joints in the main dam arch section that are longstanding. The seepage flowing over the plunge pool confinement wall was estimated at 2 gpm. The abutments were dry. There was no visible seepage through the gravity section. There was a fair amount of seepage through the lift joints in the multiple arch section. Bay 5 was observed to have the highest flow. Total flow was recorded as 110 gpm, from the September 6, 2018 instrumentation data report. The poly pipes associated with the ridge drain were damaged by the Thomas Fire in winter of 2017, and plans are in place to repair them.

Arch Section – downstream face of spillway and plunge pool below

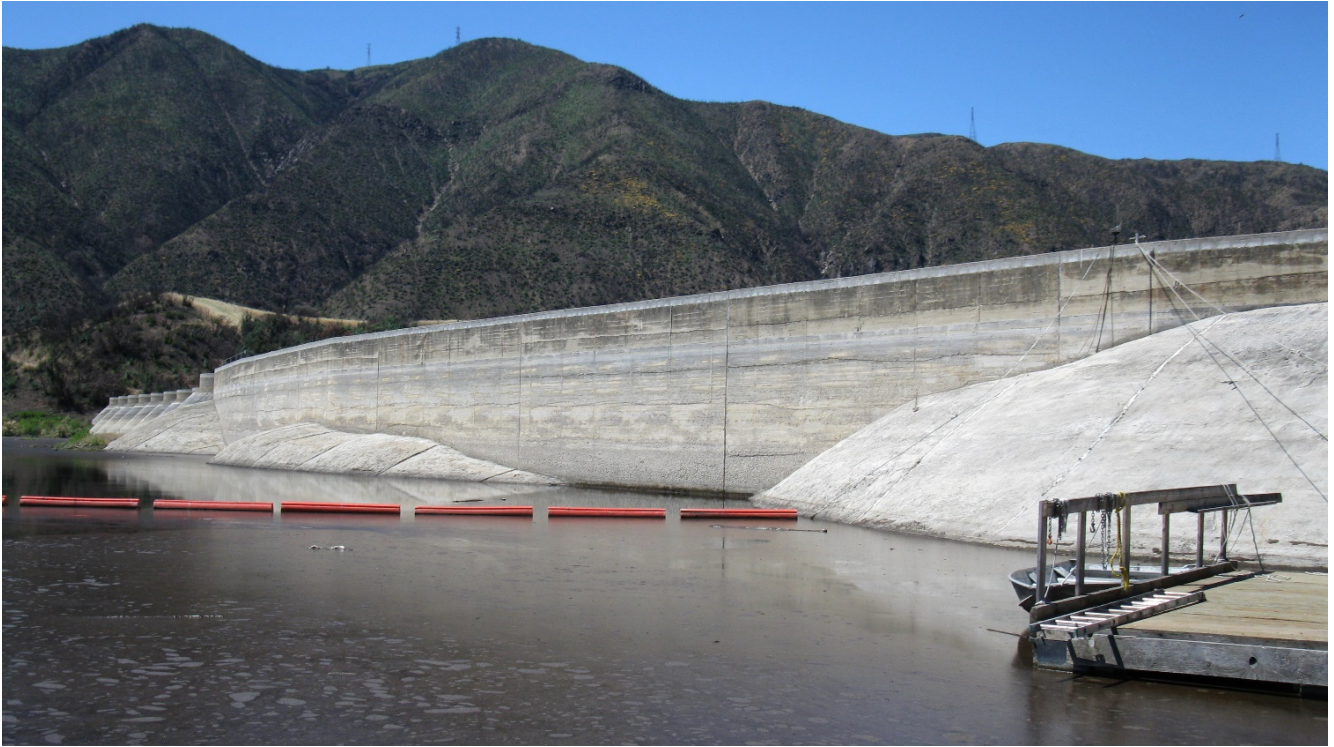
Gravity Section: All visible concrete surfaces appeared in satisfactory condition. No concerning cracks or spalls were observed. This section was in satisfactory condition.

Gravity Section – Upstream Face

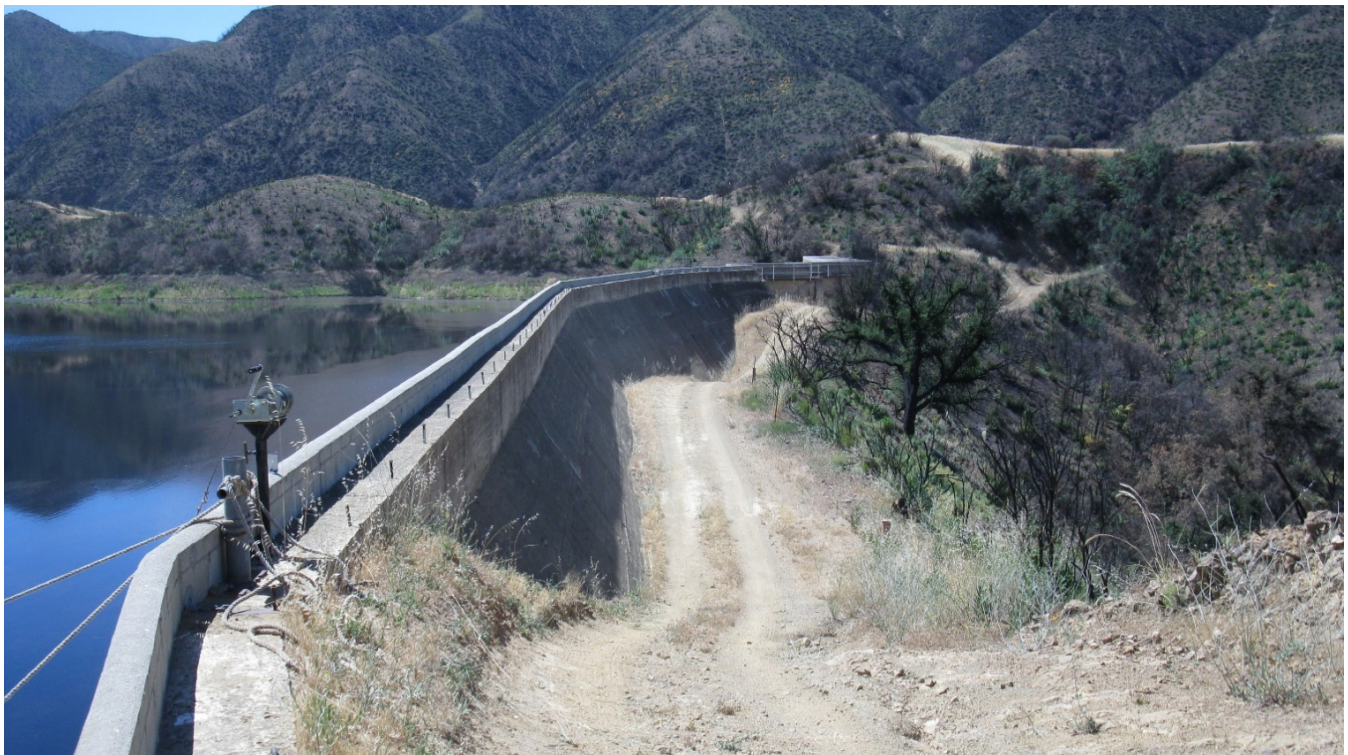
Gravity Section – Downstream face

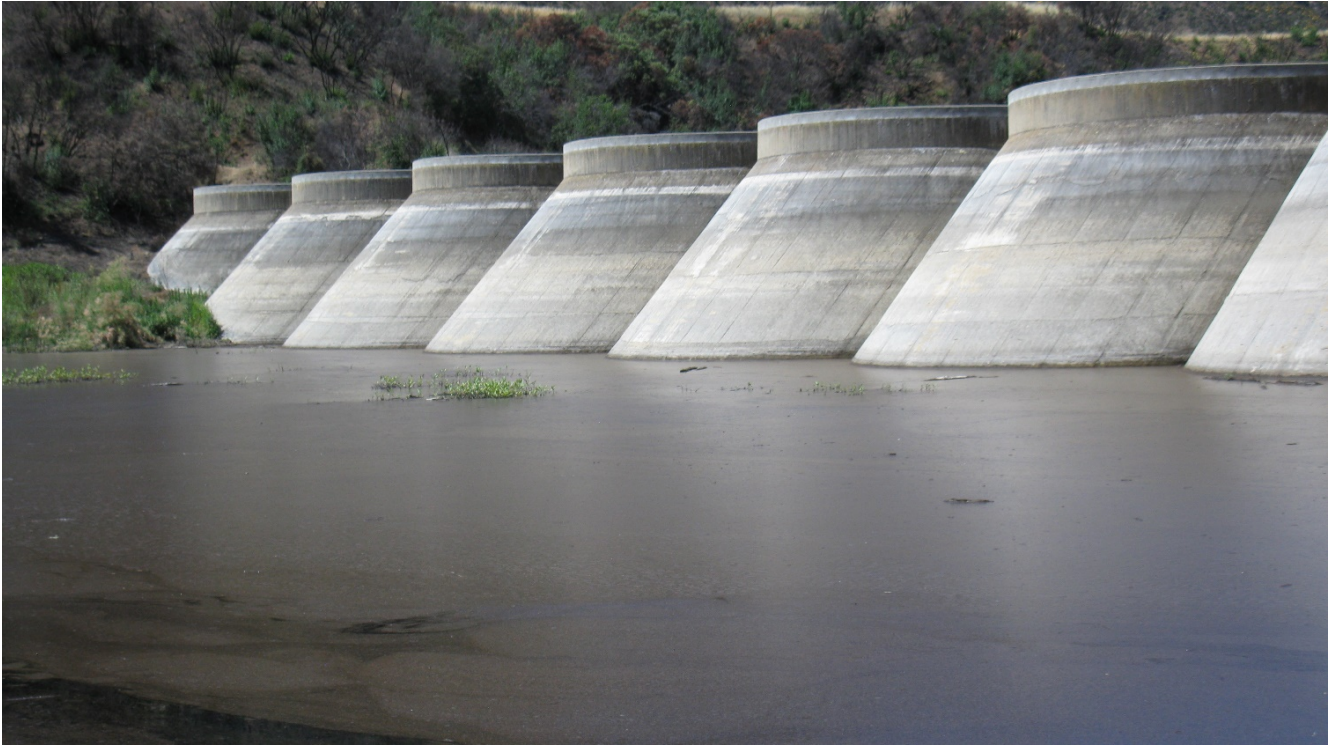
Multiple Arch Section: The crest and parapet walls were level and the visible upstream portions of the barrels appeared uniform. No obvious large cracks were detected. The soils against the downstream side of the bays were mostly wet or saturated due to heavy seepage through the lift joints. Bay 5 had the greatest seepage. Mr. Kanold indicated he is considering future plans for a seismic evaluation of the dam. Based on the observed conditions, I encouraged the endeavor.

Multiple Arch Section – Upstream View

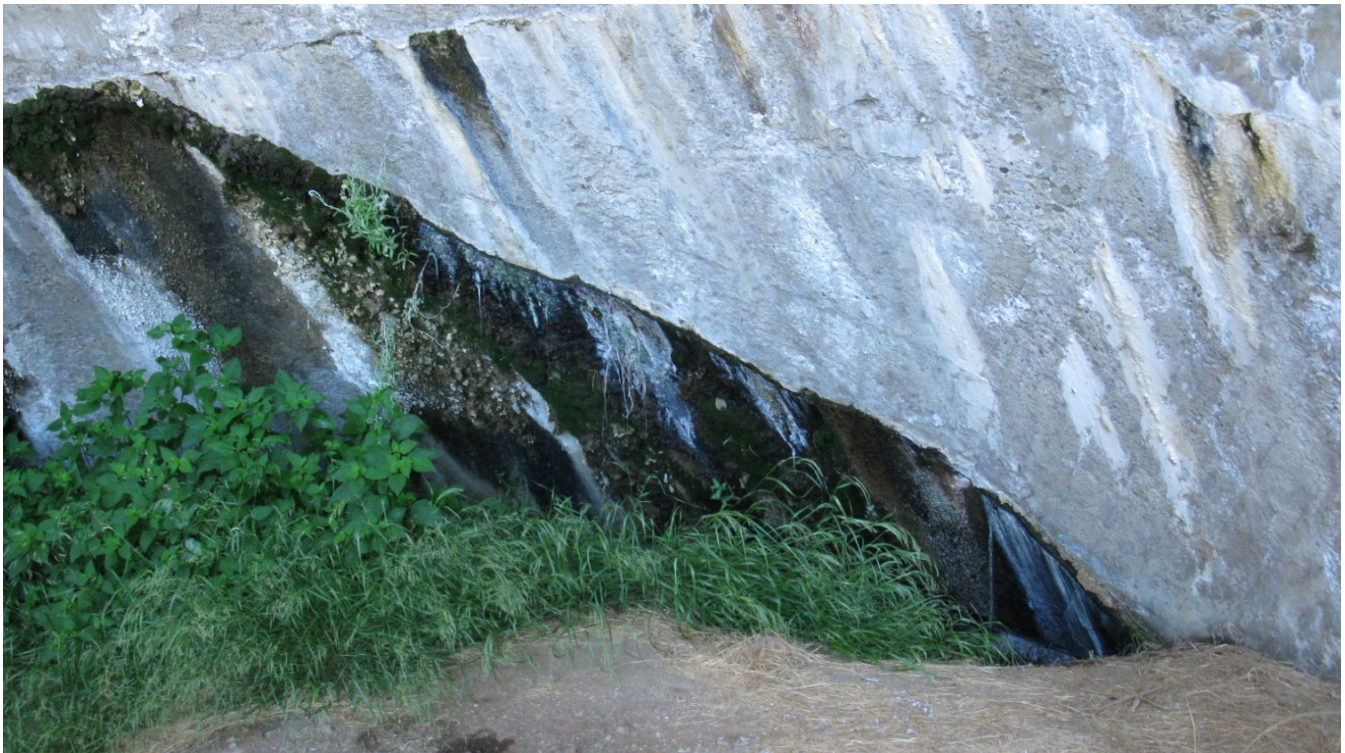
Seepage through lift joints in Bay 5 of the multiple arch section

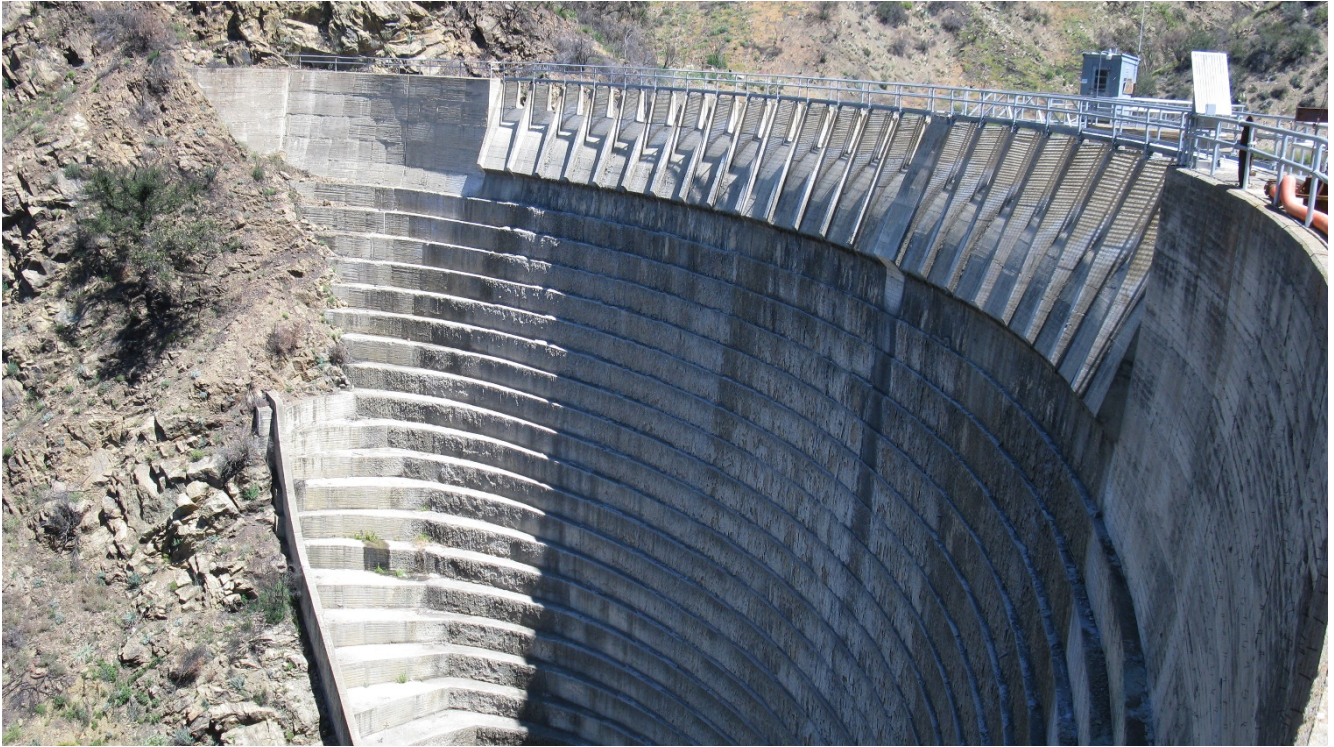
Spillway over the main dam (arch section)

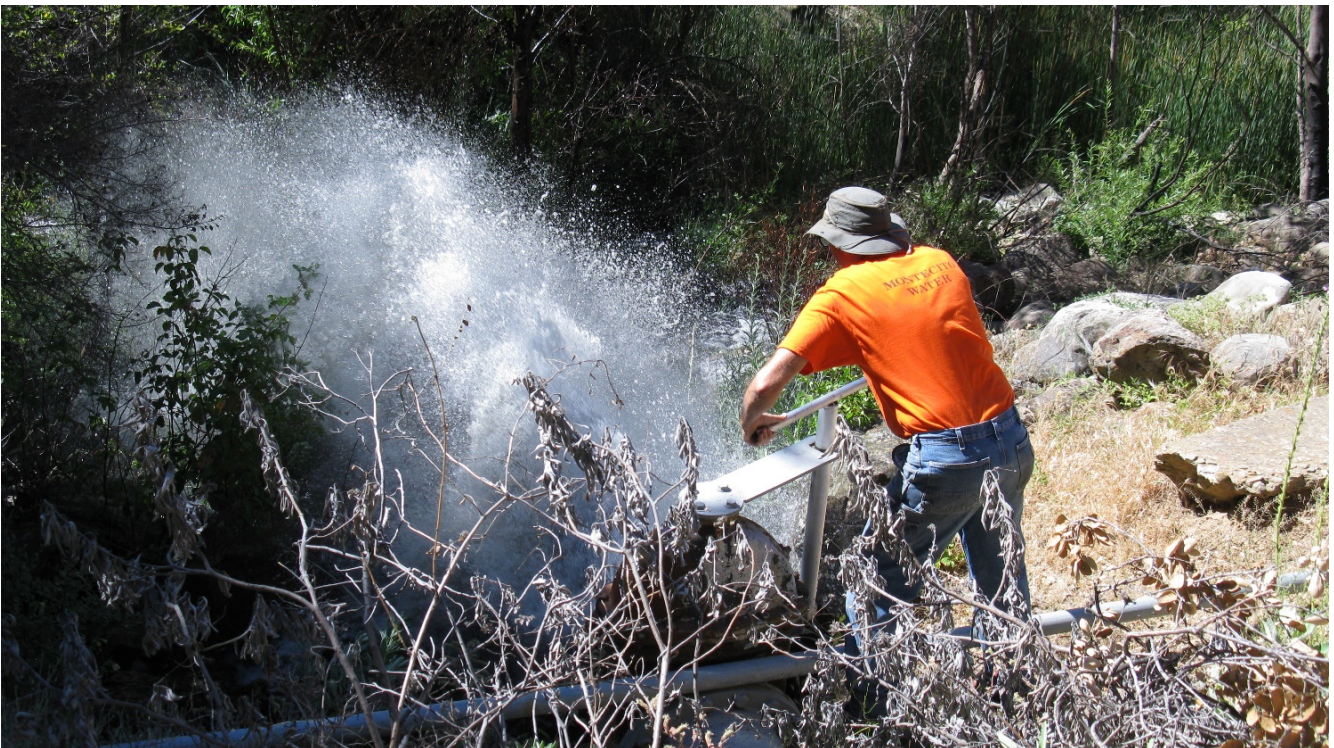
Cycling the 18-inch Blowoff Valve
